Manhole Inspection Summary

Manhole # S17AA_024MH

Insp Date: **10/31/07 9:25 AM**

Location Address: **2320 CHIEF ST**

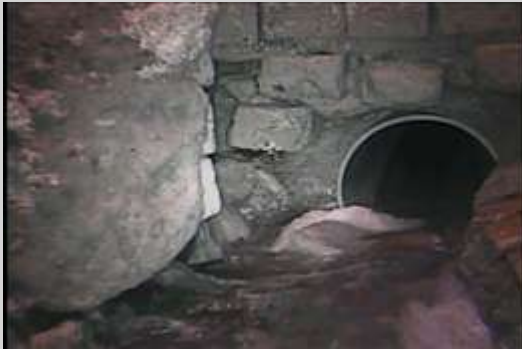
12 O'Clock Outflow

Pipe Height: **7.2** (in.) Rod and Bar (Angled)
Pipe Material: **Clay** ☐ Pipe Lined
Invert Depth: **7.80** (ft.) Flow Characteristics: **Slow**
Deposits: ☒ None ☐ Mud ☐ Sludge ☐ Debris ☐ Grease
Silt Depth: (in.) Deposits Extent:
Infiltration: **None** Pipe Seal Cond: **Sound**

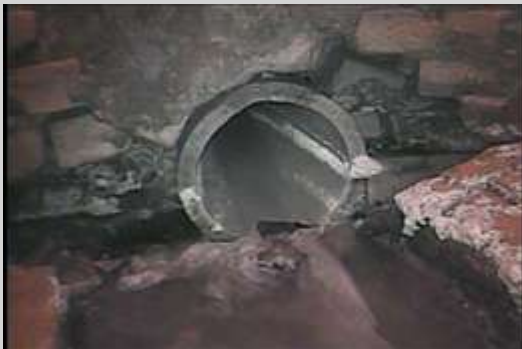
3 O'Clock Inflow

Pipe Height: **8.4** (in.) Rod and Bar (Angled)
Pipe Material: **Clay** ☐ Pipe Lined
Invert Depth: **7.72** (ft.) Flow Characteristics: **Slow**
Deposits: ☒ None ☐ Mud ☐ Sludge ☐ Debris ☐ Grease
Silt Depth: (in.) Deposits Extent:
Infiltration: **None** Pipe Seal Cond: **Sound**
